Structural Engineer's Report

Site Address: Collarenebri Grandstand, NSW

(Our Reference: 29763-SR01_A)

Structural Investigation and Recommendation for the long term repairs and temporary strengthening to allow use during the upcoming Collarenebri Races.

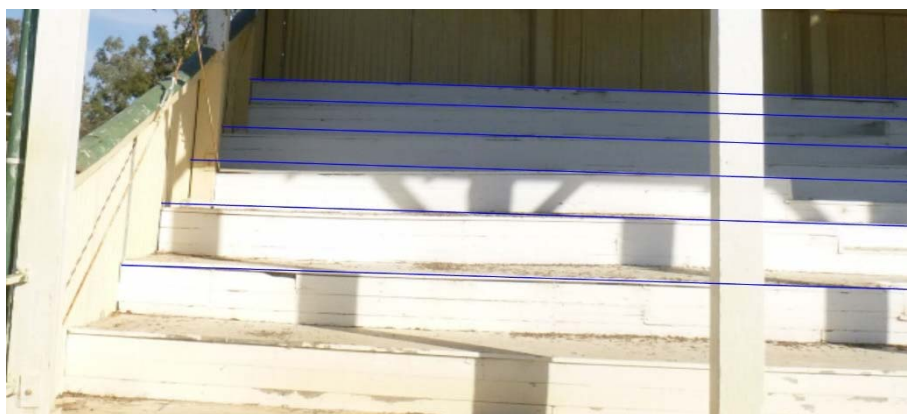
There is a considerable hump to the tier seating which has been caused by the differential settlement of the timber structure in comparison to the steel supports, as discussed below. The grandstand tiers vibrate under foot traffic as the joists to the eastern end are no longer supported at midspan.

Figure 6 – Curve to the tier seating at the eastern end.

Note: Curvature to the western end is similar. The blue lines drawn over the photo shows the variation of the seating from being level.

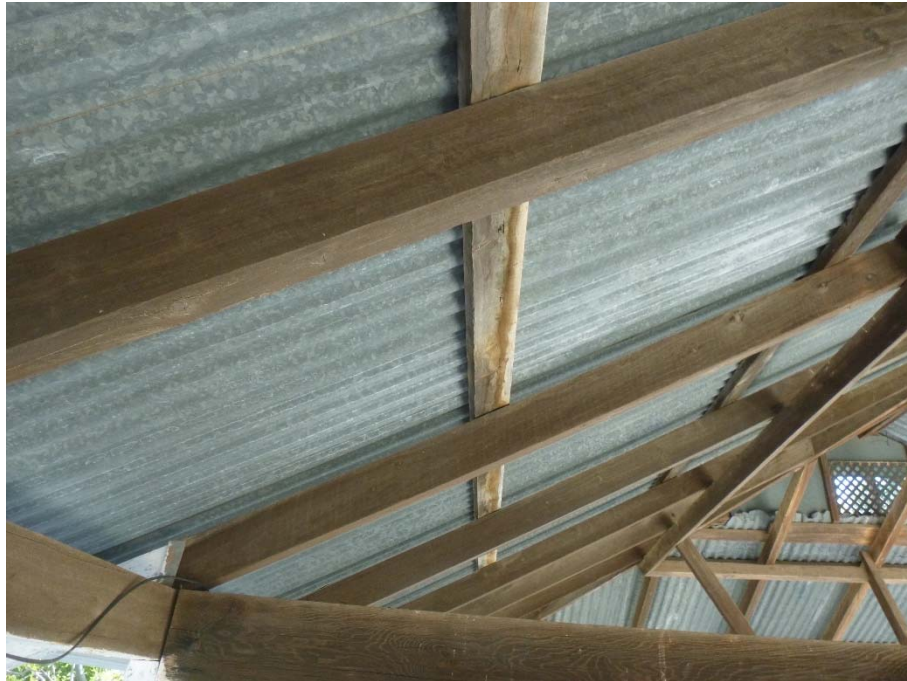
The corrugated steel external cladding has a number of defects which would allow rain to pass to the timber framing beyond. This is expected to have caused deterioration of the timbers and connections.

Figure 7 – Moisture staining to various timber battens.

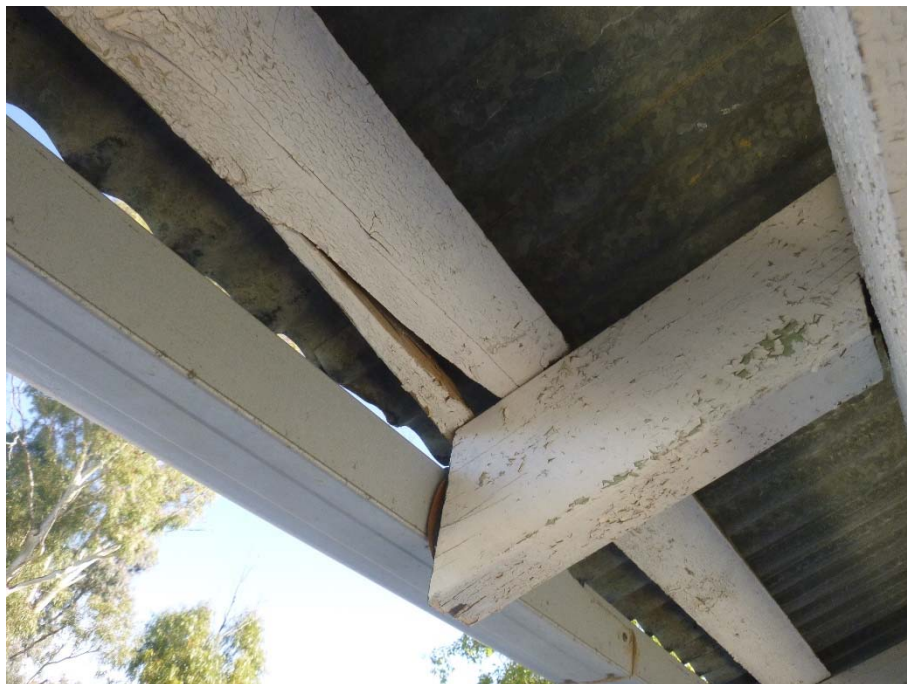
Figure 8 – Timber batten split.

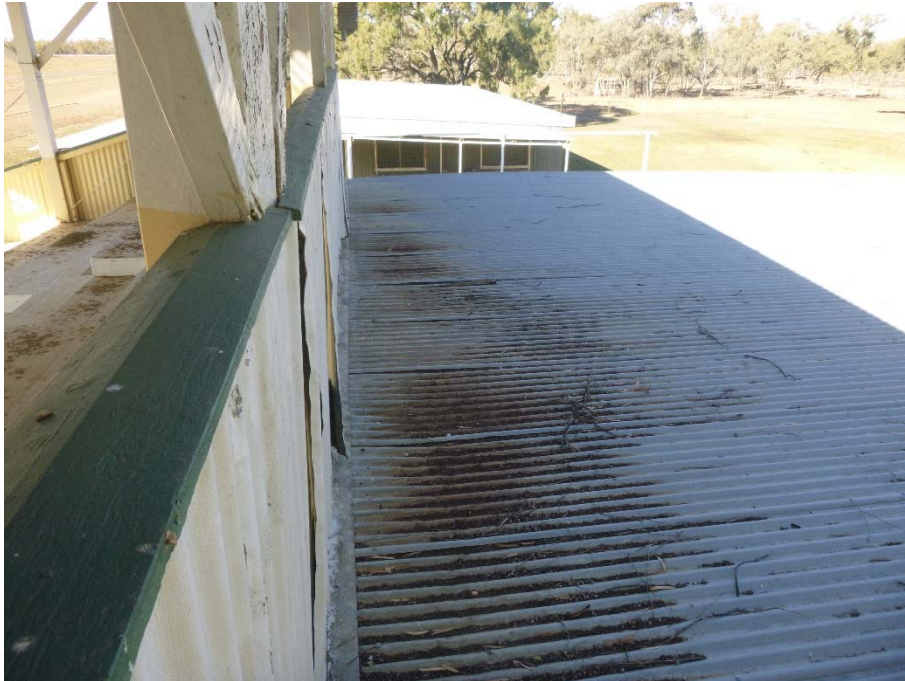
Figure 9 – External cladding is damaged throughout.

It is recommended that all external wall and roof cladding and all wall framing is removed to repair defected timber and provided access for repairs. New cladding and framing should be installed to match after the below works are complete. All deteriorating timber members should be renewed to match existing. Roof cladding should be removed and renewed after all below works are complete.

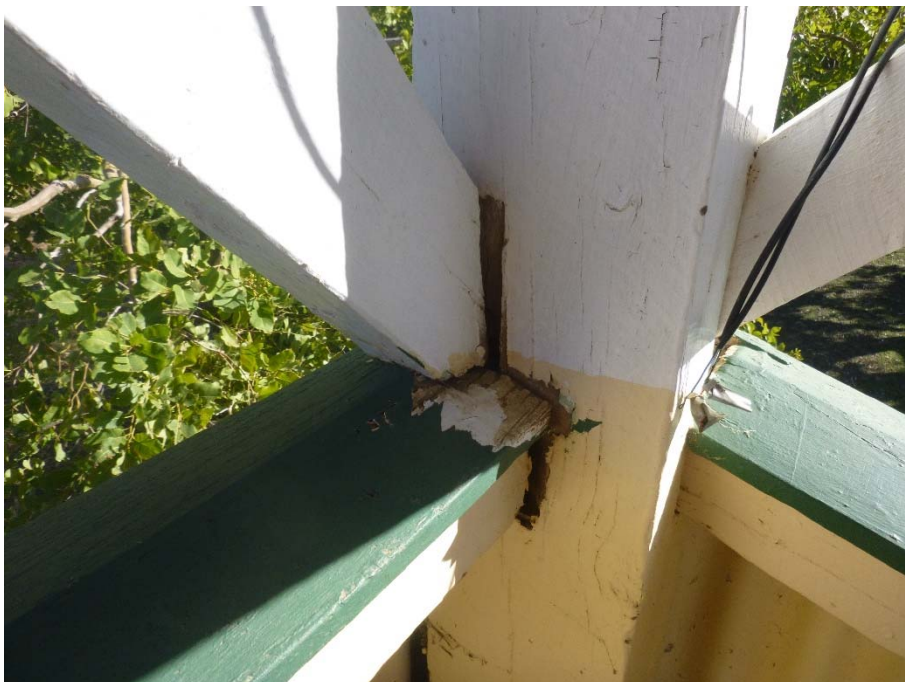
The barrier rail around the top of the tier seating is no longer adequately fixed to the columns, particularly along the south and east elevation. Due to the compromised connections, the barrier will no longer be able to resist barrier loadings to Australian Standards.

Figure 10 – Various timber connections are compromised.

Note: The existing barriers will fail under design barrier loading.

The timber connections for the barriers need to be strengthened so that they no longer deflect or open under barrier loading. Framing anchors or steel plates may be required to strengthen the connections.

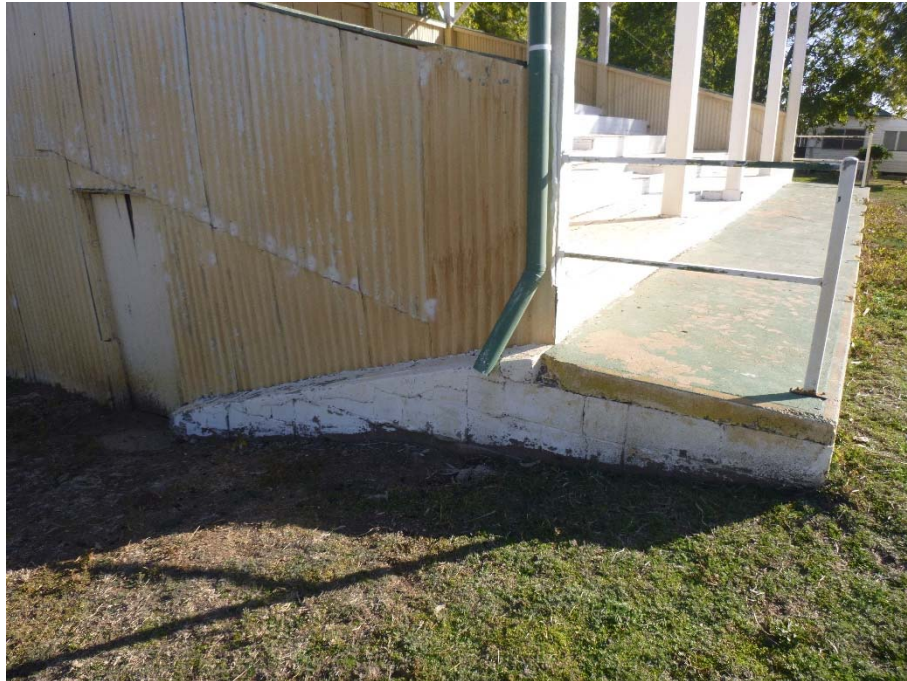
The down pipes to the grandstand discharge to the ground immediately adjacent to the structure, to the northern ends of both the eastern and western elevations. The slope of the mound to the northern elevation of the grandstand is directing the stormwater, from the downpipes, and stormwater landing along the east and west elevations, under the grandstand.

Figure 11 – Downpipes discharge to ground on the east and west elevations.

Note: The slope of the ground will direct stormwater under the door and below the timber flooring under the grandstand.

The down pipes from the grandstand should be extended underground and connected to the existing stormwater drainage or discharged away from the building sloped to encourage drainage off site.

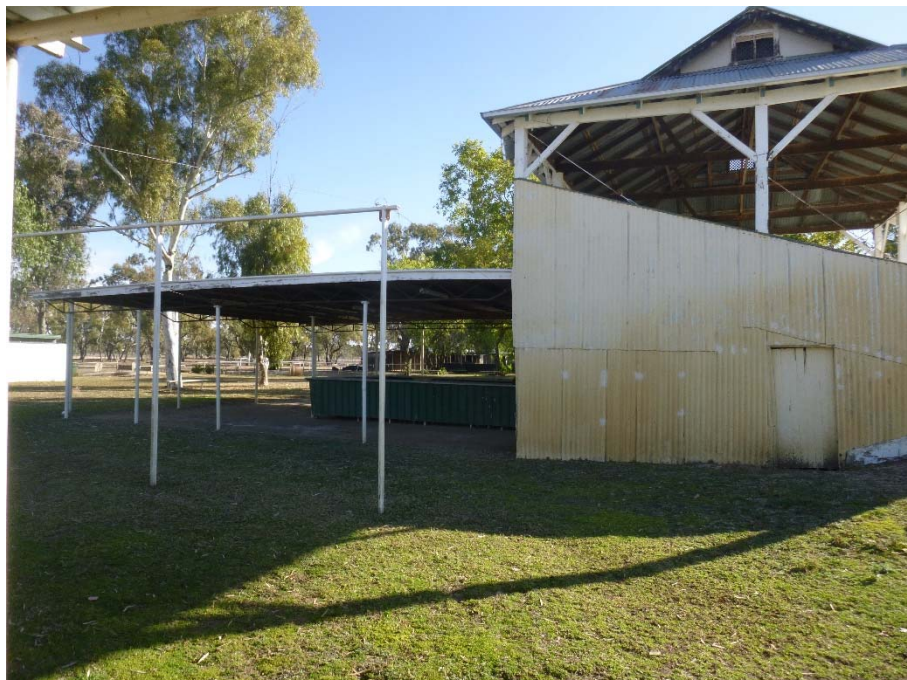
The southern wall of the grandstand appears to have settled and rotated to the south. It is expected that the additional loading of the bar area roofing and saturation of the soil around the columns has been the cause of the settlement.

Figure 12 – The southern wall of the grandstand has settled and rotated to the south.

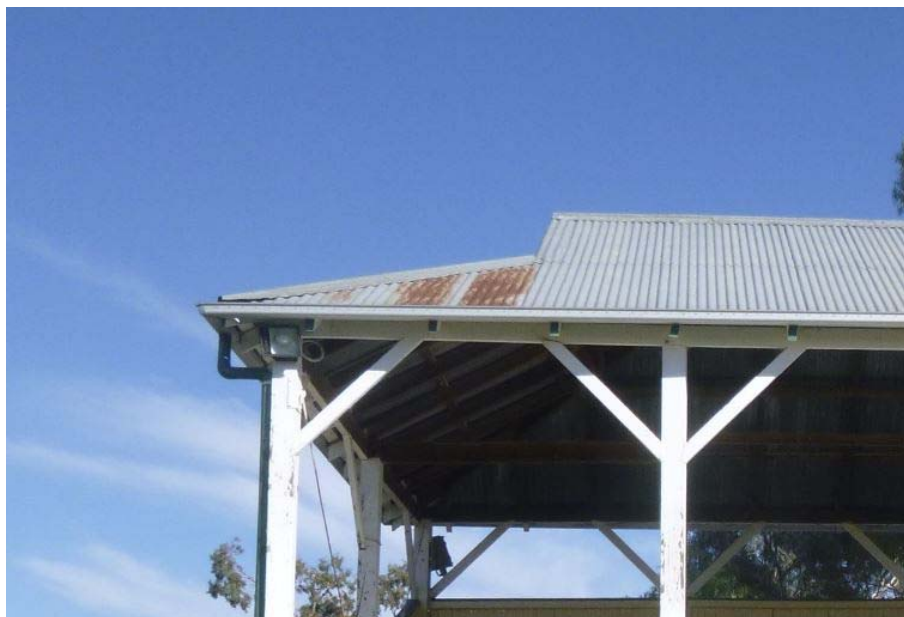
Figure 13 – The roof sheeting has reached the end of its design life.

Note: Corrosion to the cladding indicates that the protective coating has failed.

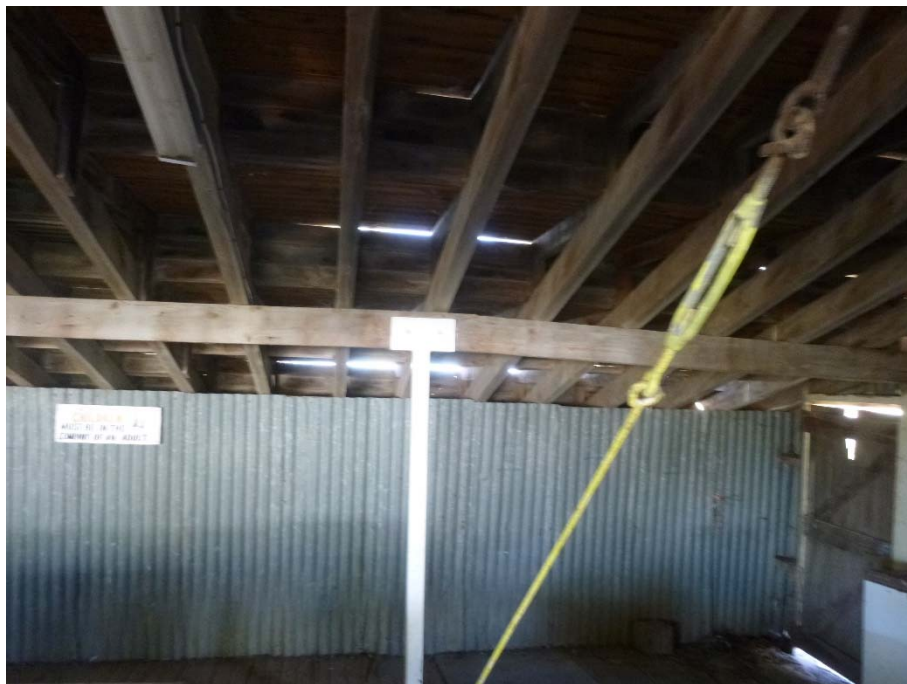
The midspan support beam to the tier seating joists has cracked above the eastern steel support column and the connection of the beam to the original timber column has also failed. The timber flooring to and around the bar under the grandstand is very uneven and has severe vibration under foot traffic. The steel rod bracing appears to be inadequate and does not appear to be fit for purpose.

Figure 14 – Eastern end of the joist support beam.

Note: The beam has split over the steel column and the connection to the timber column has failed. The tier seating joists to the eastern end are no longer bearing on the support beam.

It is expected that the original columns to the grandstand are embedded into ground in accordance with building practices at the time when the grandstand was re-located. It is expected that the steel columns, which were installed as part of the 1983 renovations, were installed with concrete footings. The differential footing movement has caused the failure of the bearer beam.

Two new 90x3.5 SHS steel columns need to be installed on 900 x 900 x 600mm deep concrete pad footings to each end of the existing bearer beam. Two new runs of columns and support beams need to be installed at quarter points along the tier seating joists. The columns are to align with the columns under the existing beam. Cross bracing to be installed as per Engineering Sketches.

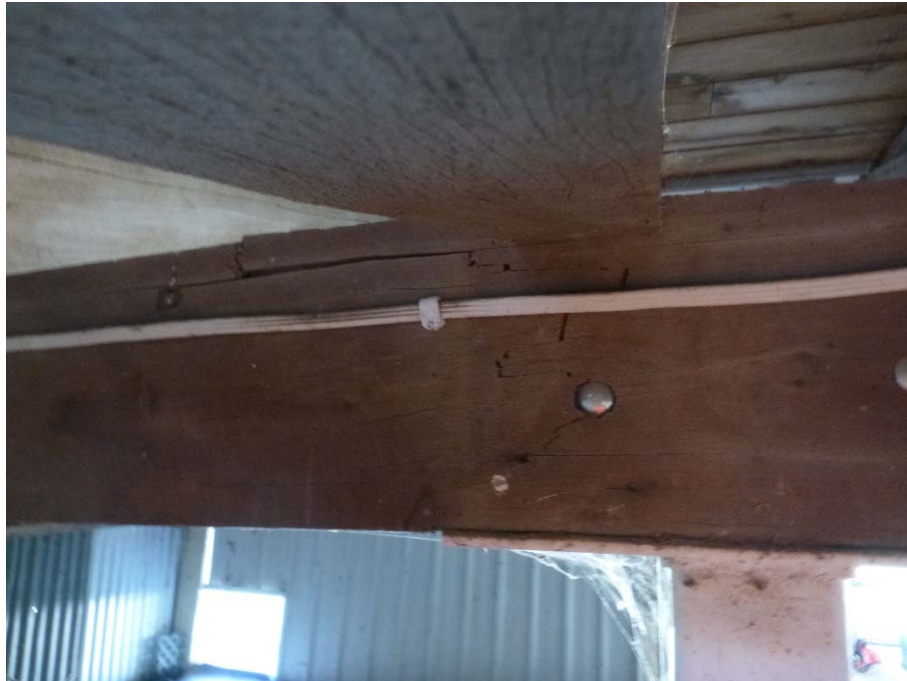
Figure 15 – Splitting to the bearer beam over the steel column.

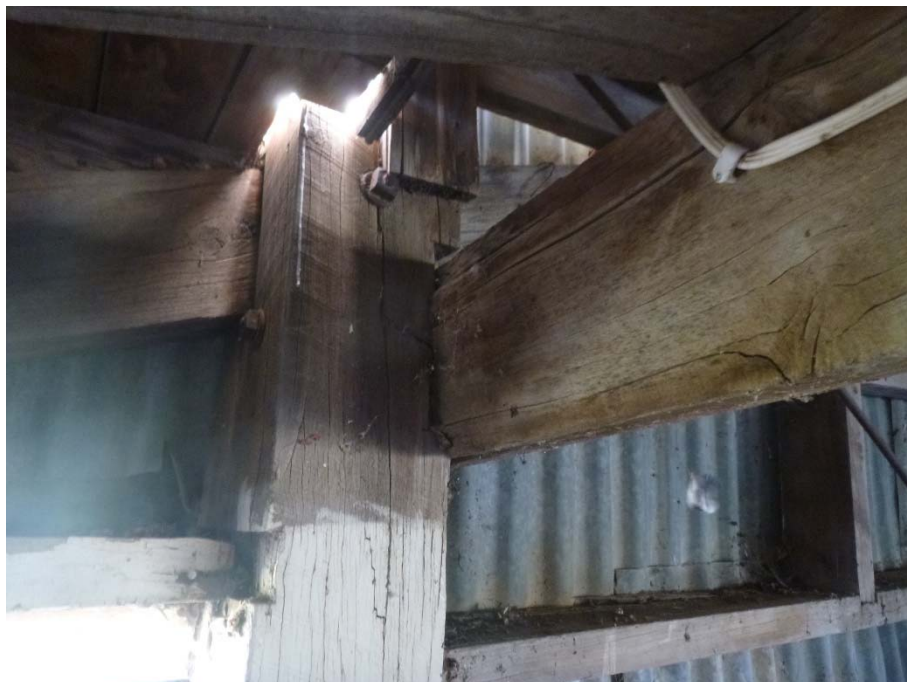
Figure 16 – Failure of the timber support beam at the timber column.

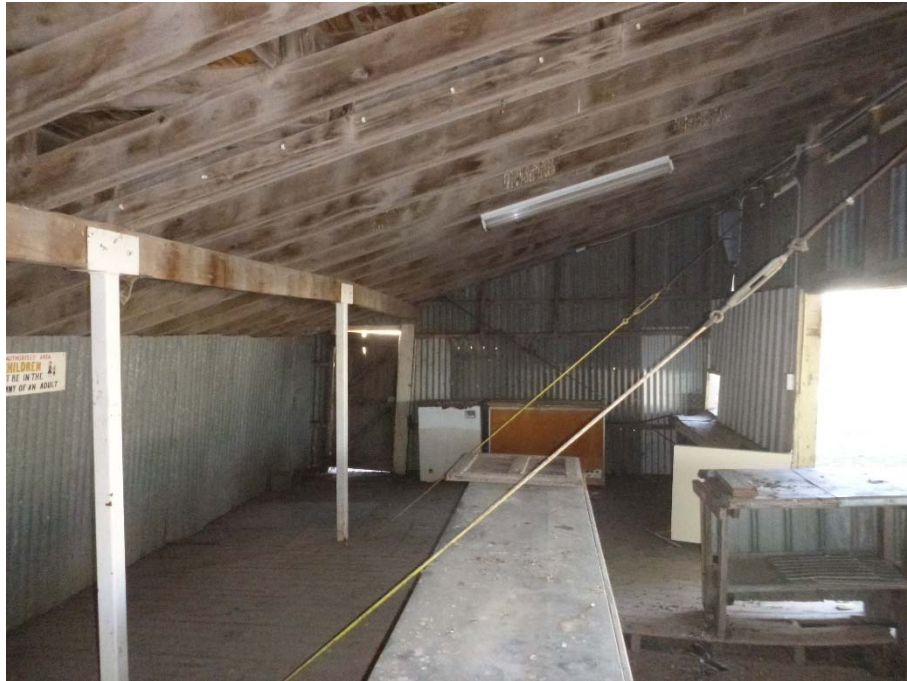
Figure 17 – The grandstand external wall has settled relative to the steel columns.

Note: The tier seating joists have bowed over the steel supports.

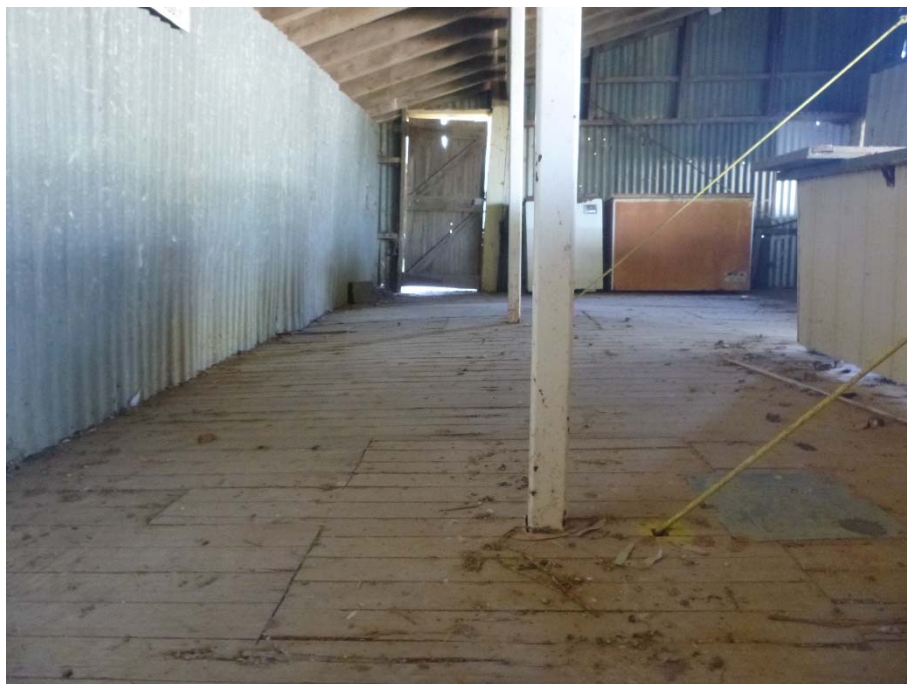
Figure 18 – Timber flooring is very uneven.

Note: Stormwater from the down pipes is entering below the floor.

It is recommended that a 100mm thick concrete infill slab is installed to the bottom of the grandstand and sloped to direct water to the south, out to the bar area and away from the grandstand.

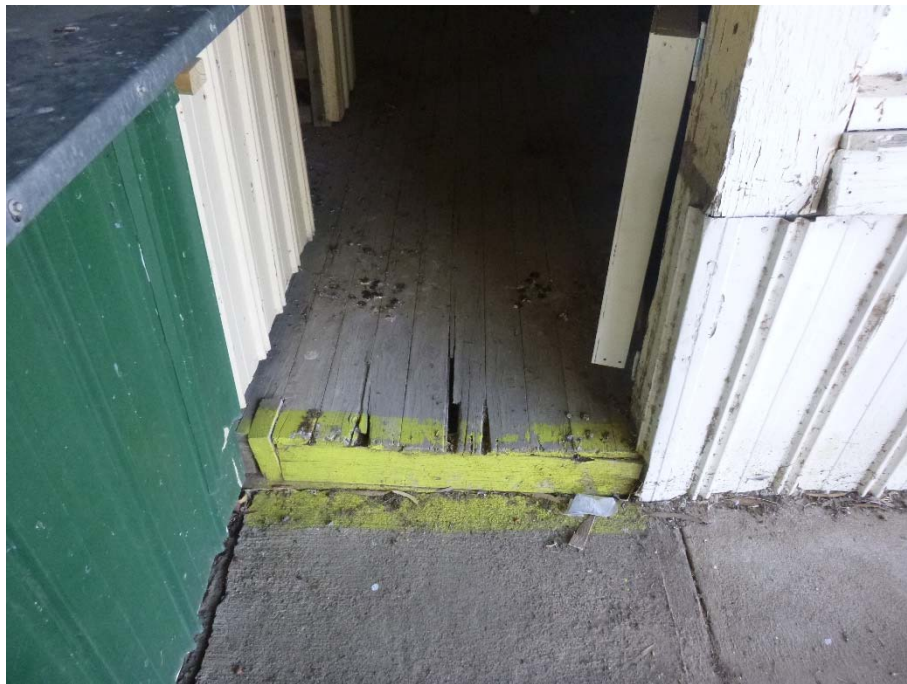
Figure 19 – Deterioration of timber floor boards.

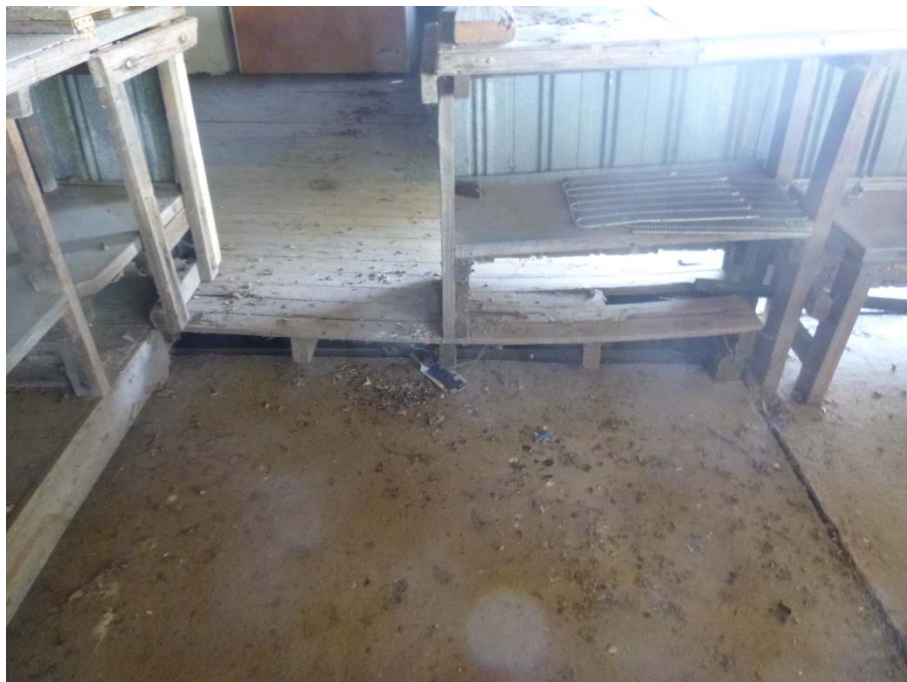
Figure 20 - Deflection of timber flooring.

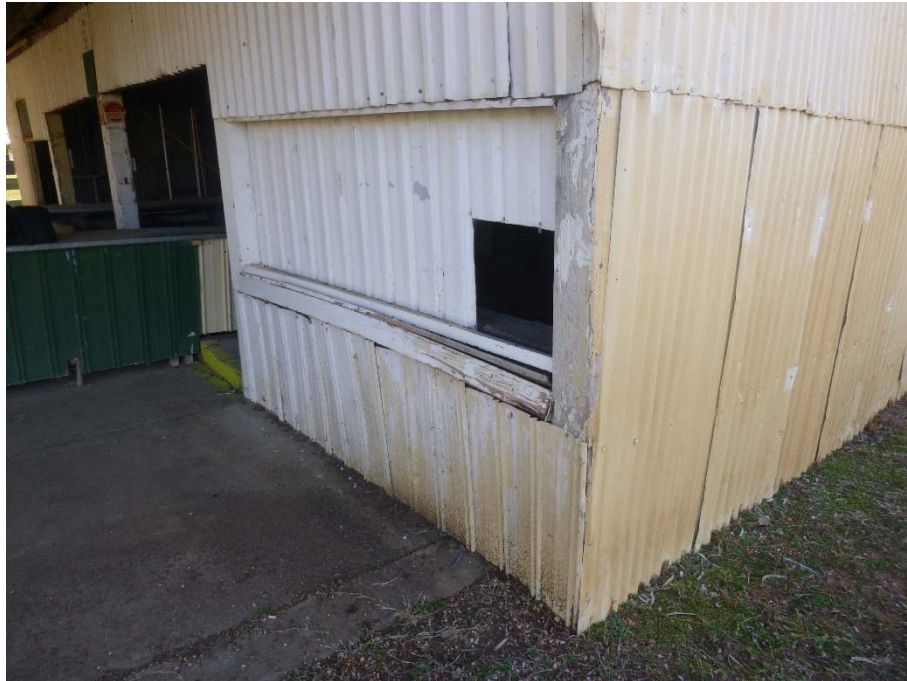
Figure 21 – Settlement of the southern wall has caused the timber framing to buckle.

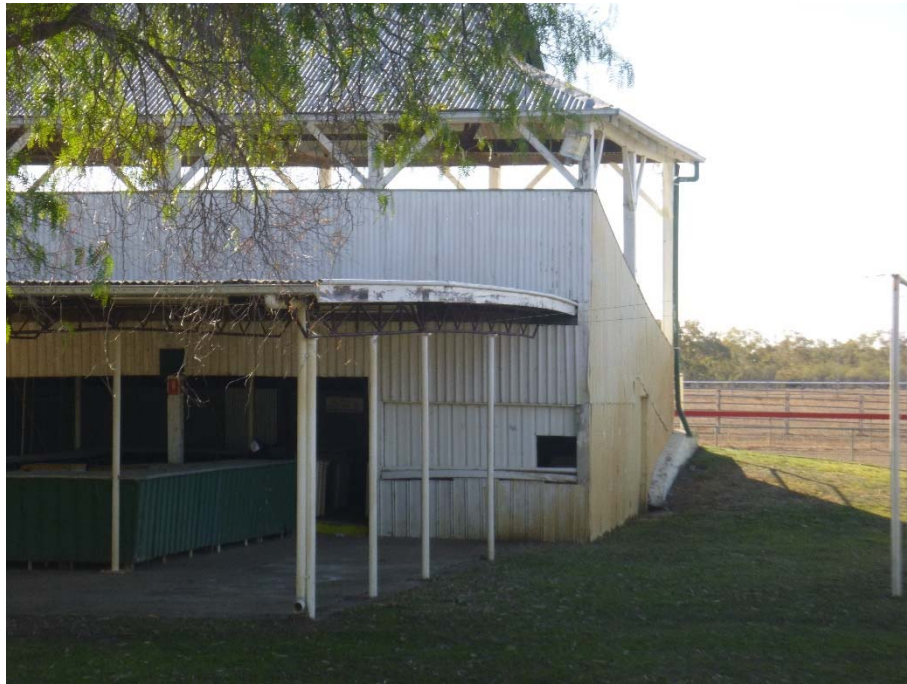
The light weight steel trusses are not uniformly supported and have bent and buckled. A number of columns are no longer vertical. The roof structure to the bar area has failed and is considered structurally inadequate. The roof is also of insufficient pitch for stormwater drainage.

Figure 22 – The roof is not straight and is back falling to the building.

Note: The southern wall of the grandstand has settled which has caused the damage.

This should also include the demolition of the southern bar area roof, including the roof sheeting, lightweight steel trusses and columns. A new standalone roof should be designed and installed after the repairs to the grandstand are complete. The design of the roof is subject to detailed design.

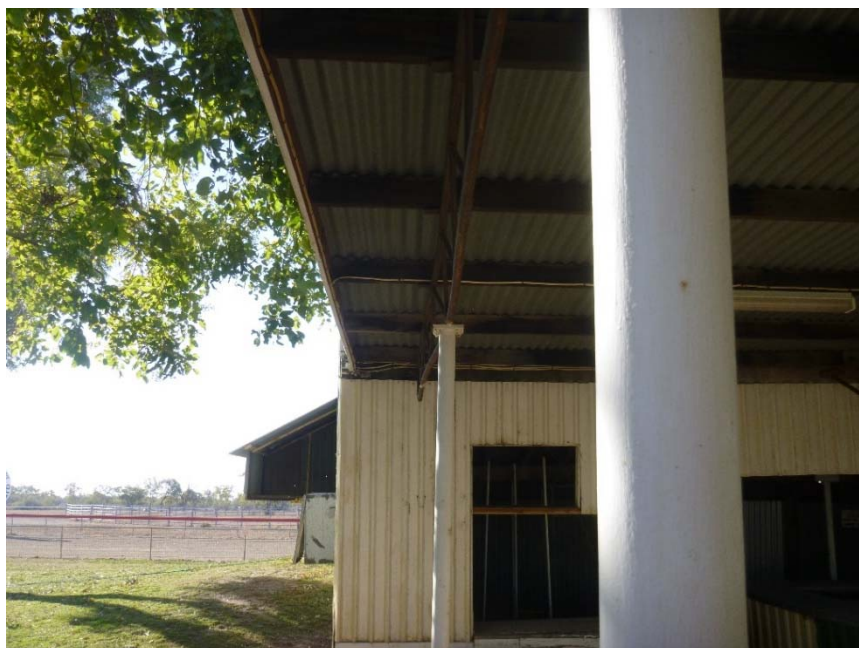
Figure 23 – Western lightweight steel truss has buckled.

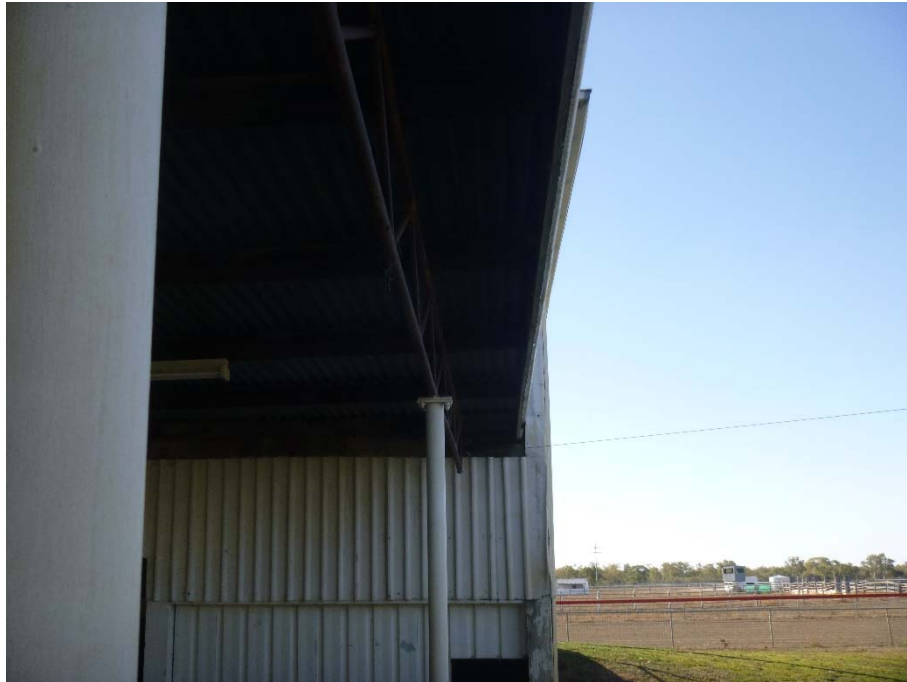
Figure 24 – Eastern lightweight steel truss has started to buckle.

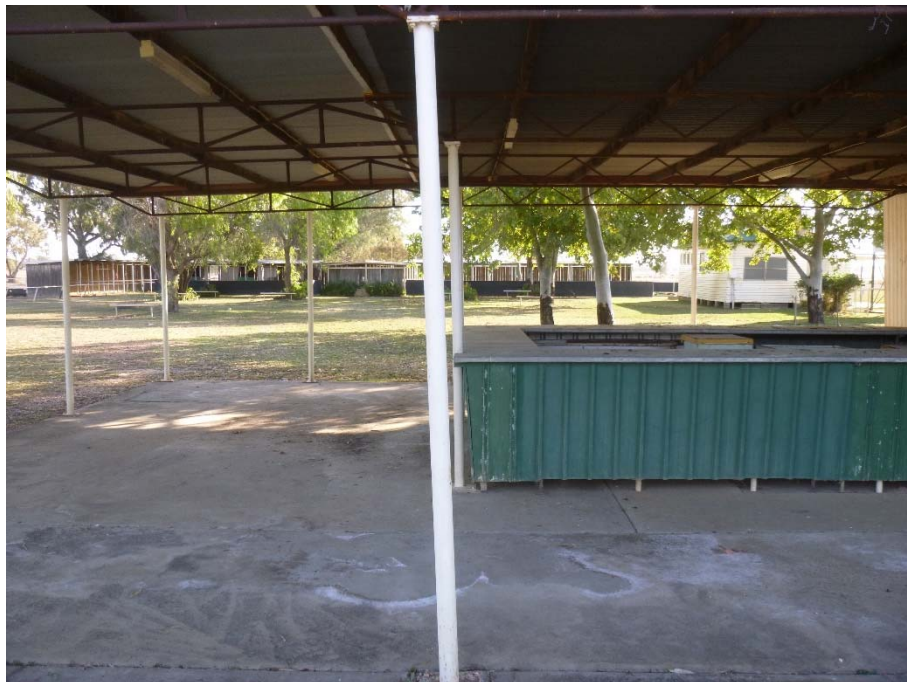
Figure 25 – Columns are no longer vertical.

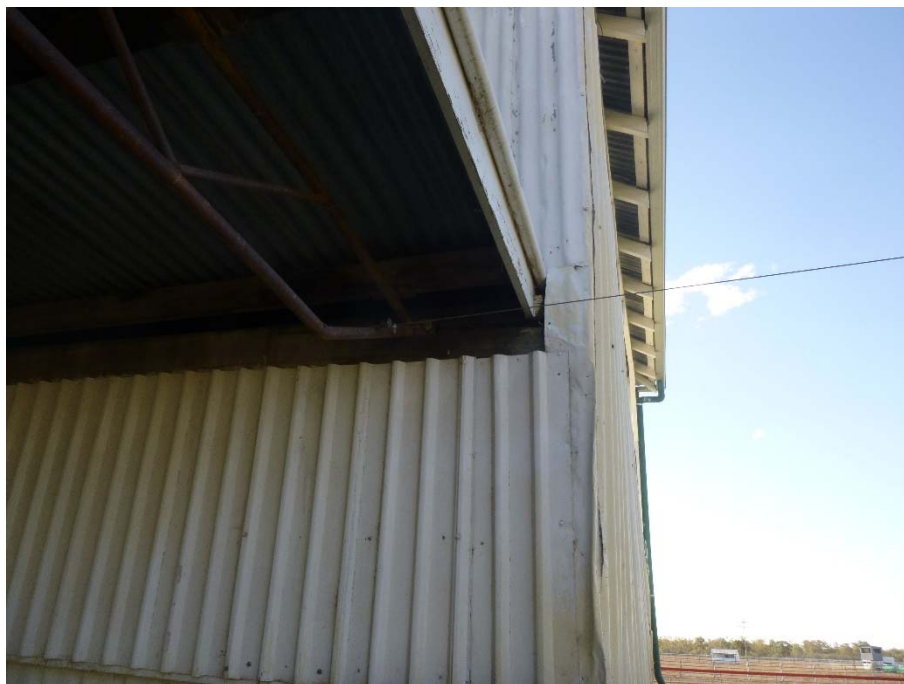
Figure 26 – The timber beam where the bar area connects has split at the eastern end.
