**ATTACHMENT DOCUMENT  
FOR  
ORDINARY COUNCIL MEETING**

**Tuesday 25<sup>th</sup> October, 2016**

1. AUDIT OF WASTE MANAGEMENT FACILITIES UNDERTAKEN BY GHD  
DATED 15 SEPTEMBER 2016.
2. CLEARANCE REPORT BY ENVIROSCIENCE - 40-42 PANDORA STREET, LIGHTNING  
RIDGE BMX BIKE TRACK.

## **Infrastructure Advisory Services for local Councils Audit of Waste Management Facilities**

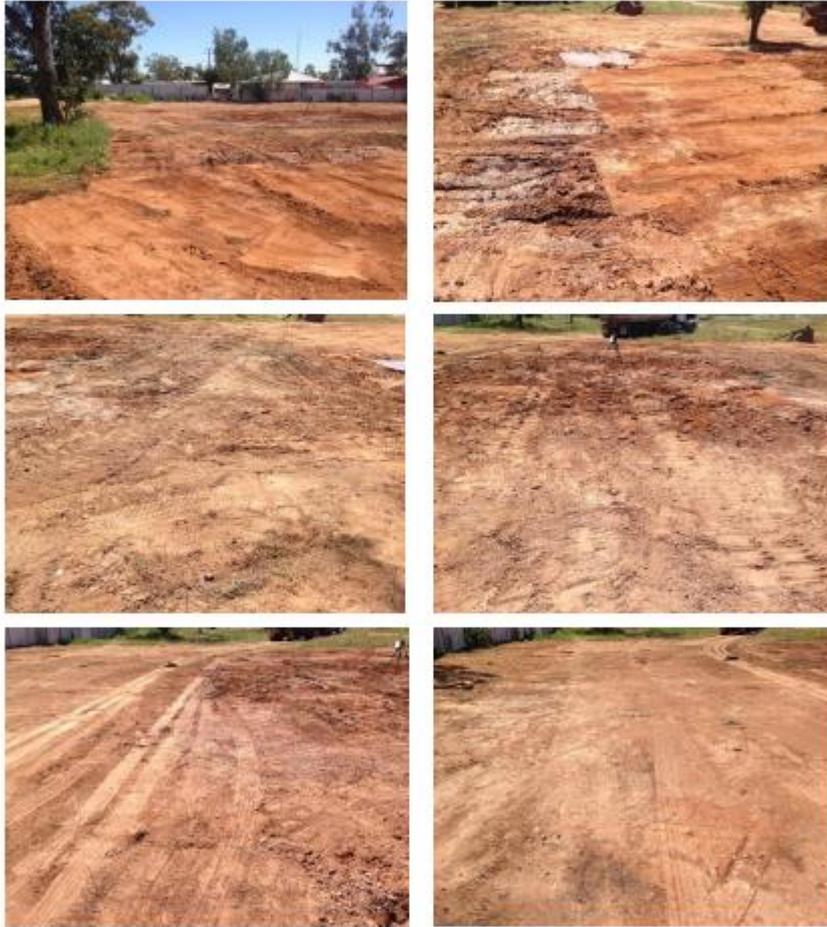
Table 1: Images of Asbestos Removal and Clearance

The inspection was carried out at the completion of the asbestos removal on 7<sup>th</sup> October 2016. It was found that the visible asbestos contamination had been satisfactorily remediated from

the above area; please refer to the images below, which depict the satisfactory completion of the scope of works.
